DATE OF DOC	DATE REC'D	DATE OUT	SUSPENSE DATE	CROSS REFERENCE OR POINT OF FILING
	30 JULY 64			
TO FROM SUBJ. DD32000X A-1H Aircraft Accident.				ROUTING
CY 1 CNO 2 D/Tech * * * Col. G... " " "				DATE SENT
COURIER NO.	ANSWERED	NO REPLY	4

OX CART SECRET**A. History of Flight**

On 9 July 1964 Lockheed test pilot [REDACTED] was scheduled in A-12 Aircraft number 133 for a maximum A/B climb to Mach 2.8 and sustained flight at Mach 2.8 and 78,000 feet. Route to be flown was Copper Bravo route (Photo 4844). Weather was better than usual and was not a factor in this accident. Aircraft inspection and personal equipment hook-up was performed by qualified ground crews in accordance with flight handbook and organization procedures. Take-off at 0820 PDT was normal (210K and 7400 feet ground roll with aircraft weight 112,000 pounds). An F-101, No. 312, piloted by Col R. J. Holbury and Capt R. J. Roussell was to be used for chase within the capabilities of the aircraft. After take-off chase advised that number 133 was clean and smooth. Both aircraft checked in with Bungalow, who advised good IFF/SIF contact. [REDACTED] performed maximum A/B climb to 78,000 feet and 2.8 Mach. At the northern li

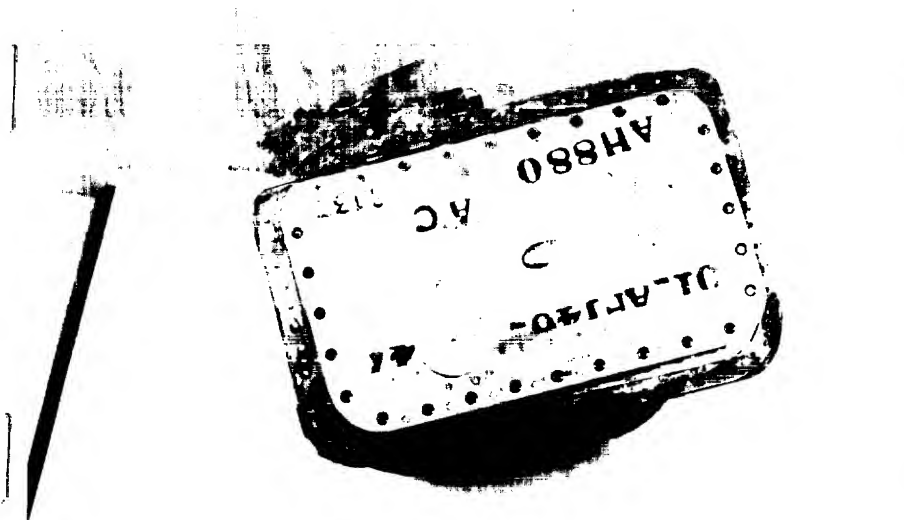
4694

PITCH & YAW
RATE GYRO
PACKAGES

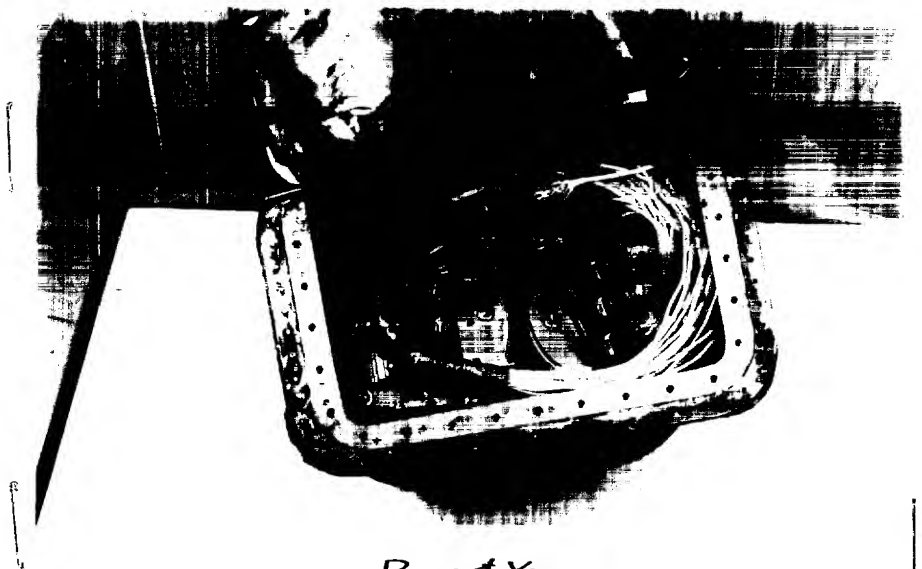
4735

*PITCH & YAW
RATE GYRO
PACKAGES*

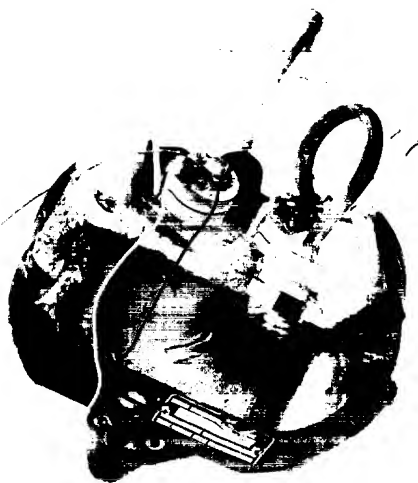
1651

ROLL RATE GYROS

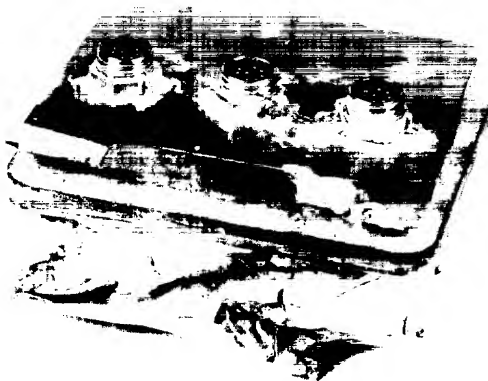
4688

*LATERAL
ACCELEROMETER
PACKAGE*
